# ENVIRONMENTAL AND SOCIAL AUDIT

## **NTARUKA HYDROPOWER PLANT**

### **FINAL REVISED REPORT**

**March 2021**

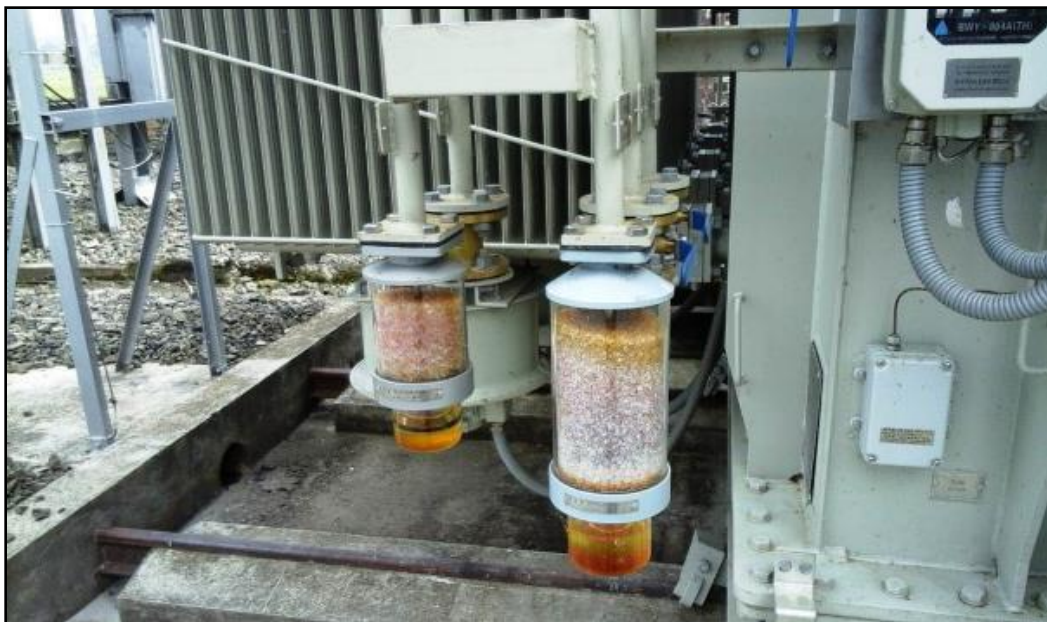
**Fig. 3: Deteriorated Silica Gel.**

It was noted that the quality of the silica gel had deteriorated, resulting in accumulated moisture levels (Fig. 3 above). The transformer however, does not exhibit any signs of distress and is devoid of any tell-tale signs of leakage and other associated effects of deterioration.

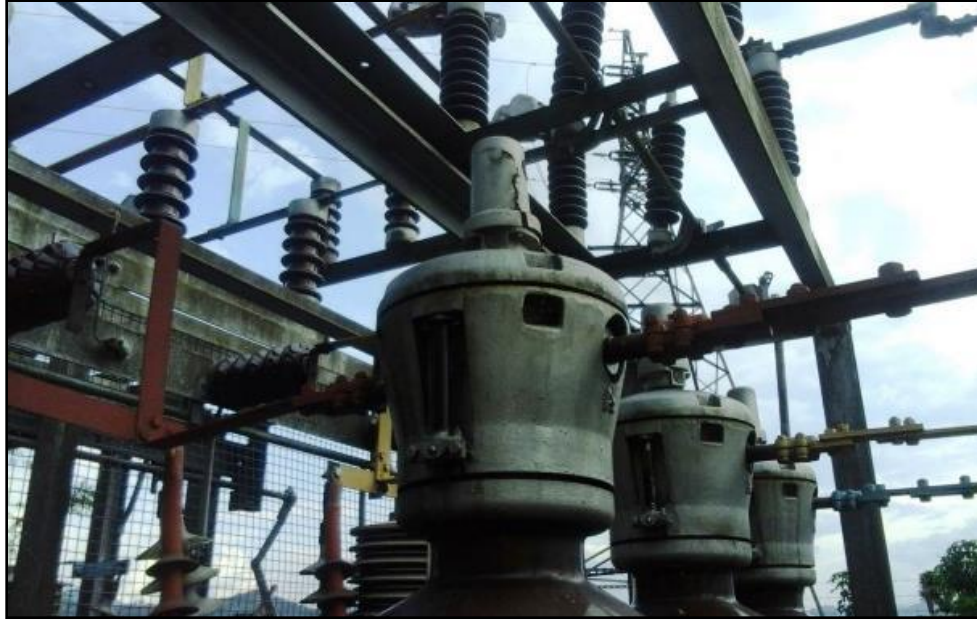
It was also noted that the CTs had deteriorated over time especially the ones on the Ruhengeri circuit/feeder. One is cracked at the top as well as an oil seepage on another CT.

**Fig. 4: Cracked CT for one of the Outgoing 30kV Feeders.**

The Red phase CT on the outgoing Ruhengeri 30kV feeder is cracked at the top and is bound to be hazardous. Also, the Blue phase surge arrester on the same feeder was shattered/broken and disconnected.

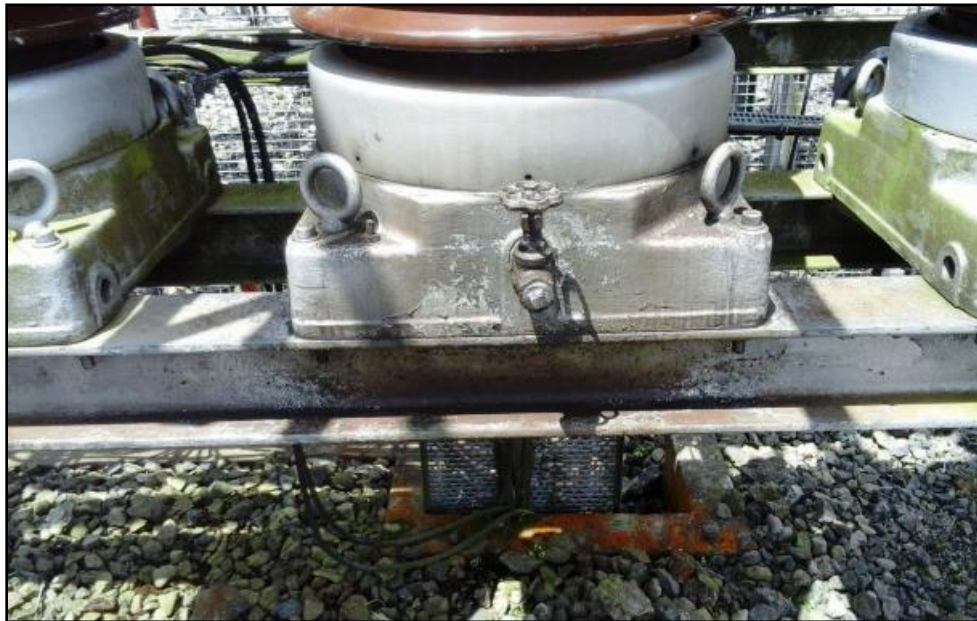
**Fig. 5: Oil Seepage on a CT for one of the Outgoing 30kV Feeders.**
