# ENVIRONMENTAL AND SOCIAL AUDIT

## **NTARUKA HYDROPOWER PLANT**

### **FINAL REVISED REPORT**

**March 2021**

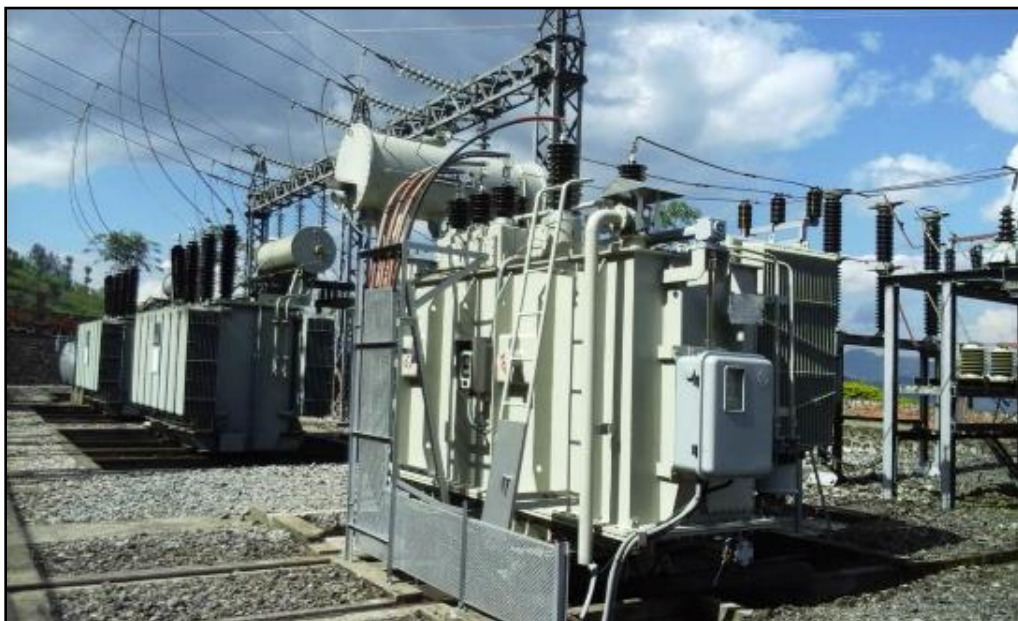
A visual inspection of the existing equipment within the substation was conducted and it was found out that the equipment age and physical status basing upon information received from the plants' operator regarding historical performance.

**Fig. 2: Part of the Outdoor Substation/switch yard “three outdoor transformers” at Ntaruka.**

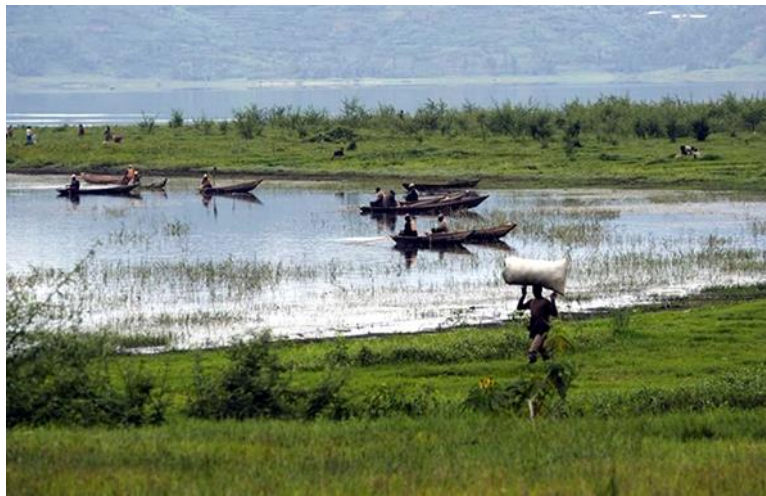
Lake Burera stands at 1,860 above sea level. In general, due to its hilly topography, Rwanda shows high susceptibility to landslide, 42% of the country's area is classified as moderate to very high susceptibility (MIDIMAR, 2015). The water level in Lake Ruhondo is 1,759.2m. The Environmental Organic Law and the Land Law both prescribe buffer a distance of 10 meters for crops and 20 meters for housing respectively near waterbodies. Around some marshlands, buffer zones of 50 meters have been delineated and agro-forestry species have been planted. Visual inspection revealed that this regulation is observed along both Burera and Ruhondo lakes.

**Fig. 17: Buffer zone on Ruhondo Lake**

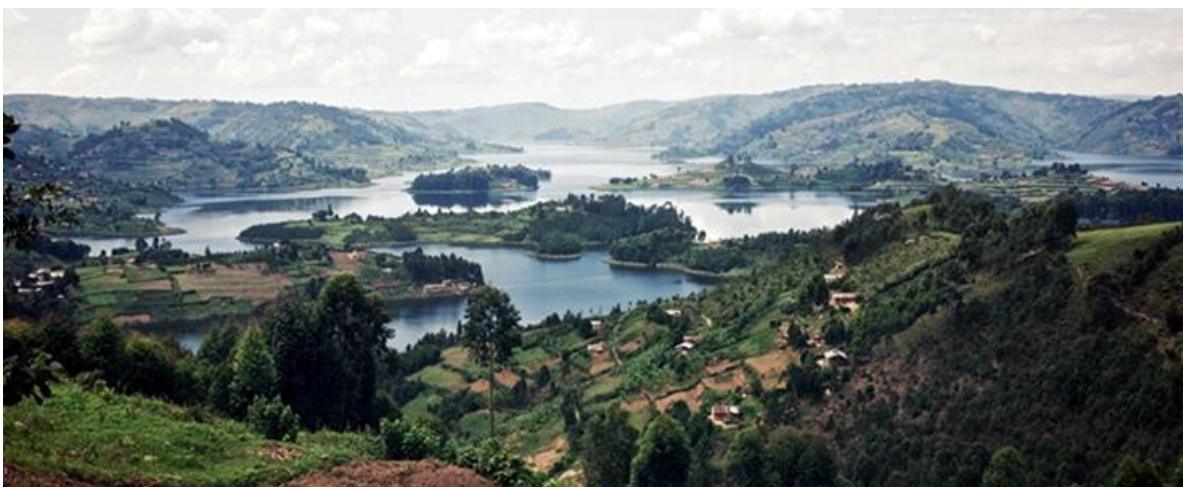
Available data, site visits and discussions with local inhabitants did not indicate severe slope failures at the periphery of Lakes Burera and Ruhondo since the impoundment of the Ntaruka dam. The national risk atlas of Rwanda also does not list Lake Burera zone among areas that are prone to high or very high landslide hazards.

**Fig. 18: View of peripheries of Lake Burera and Ruhondo**

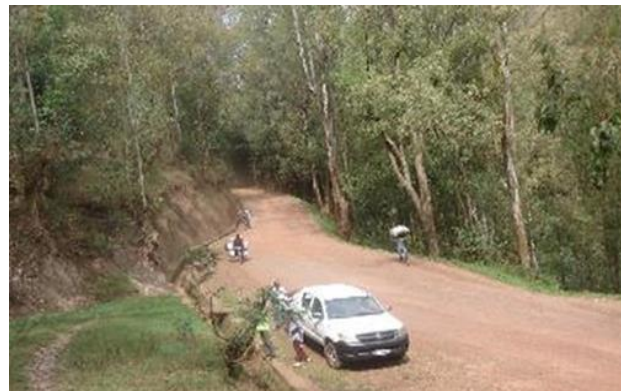
The road from the power plant to the intake is very narrow and has eucalyptus trees planted on both sides. It has proper water drainage channels. It was noted that the penstock crossed the road from the intake to the powerhouse.

Road from the powerhouse to the intake

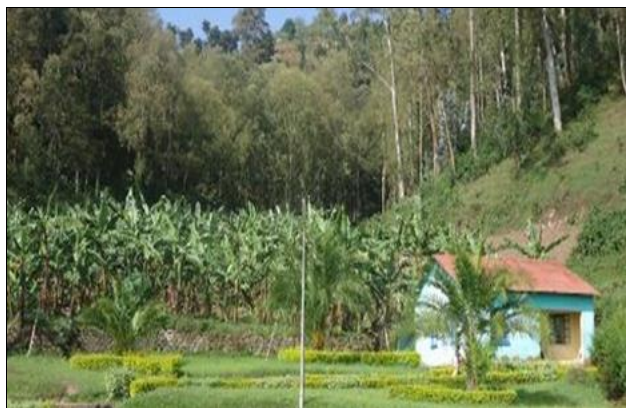
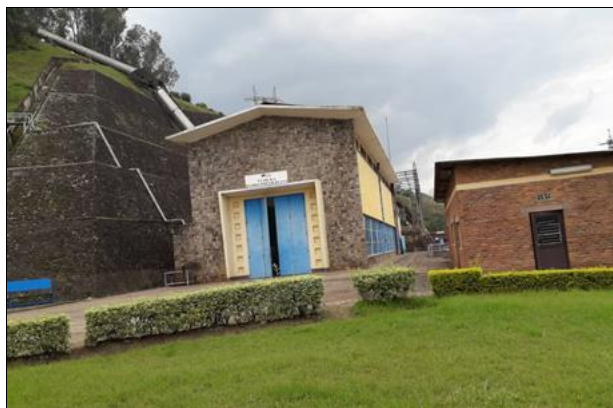
**Fig. 30: Tree planting (eucalyptus) on slope between dam and power house**

In order to increase amount of inflow to Lake Burera, we recommend intensive soil and watershed conservation work on Burera catchment especially on open land, irrigation areas and agricultural land cover. This will improve ground water recharge and surface runoff. There is some tree planting in the project site (**Fig. 24**). Consultations with the technical team of the power plant indicated that the trees were mainly planted as a measure to reduce soil erosion on the slope between Ntaruka dam and the powerhouse.

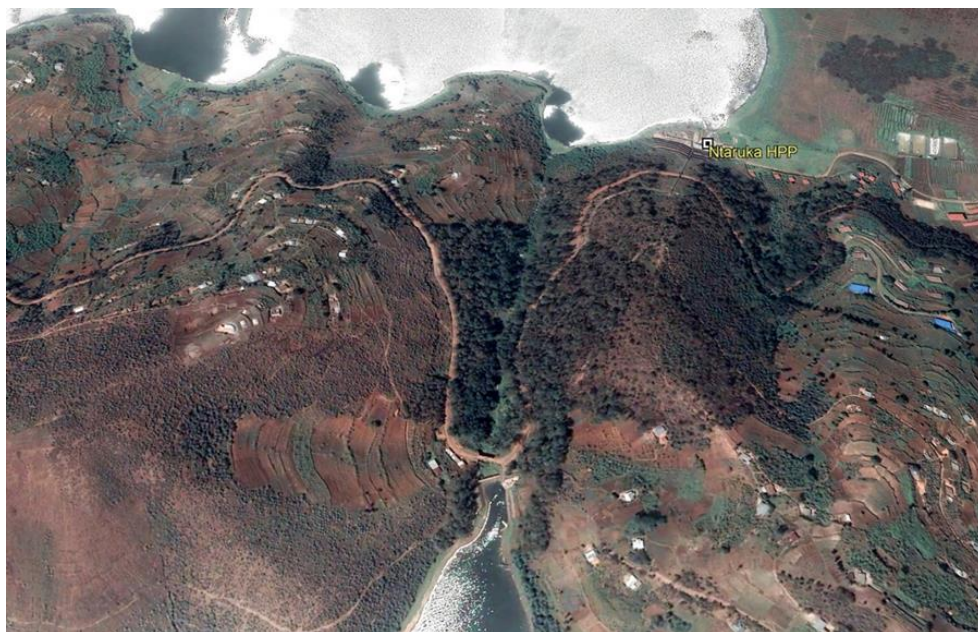
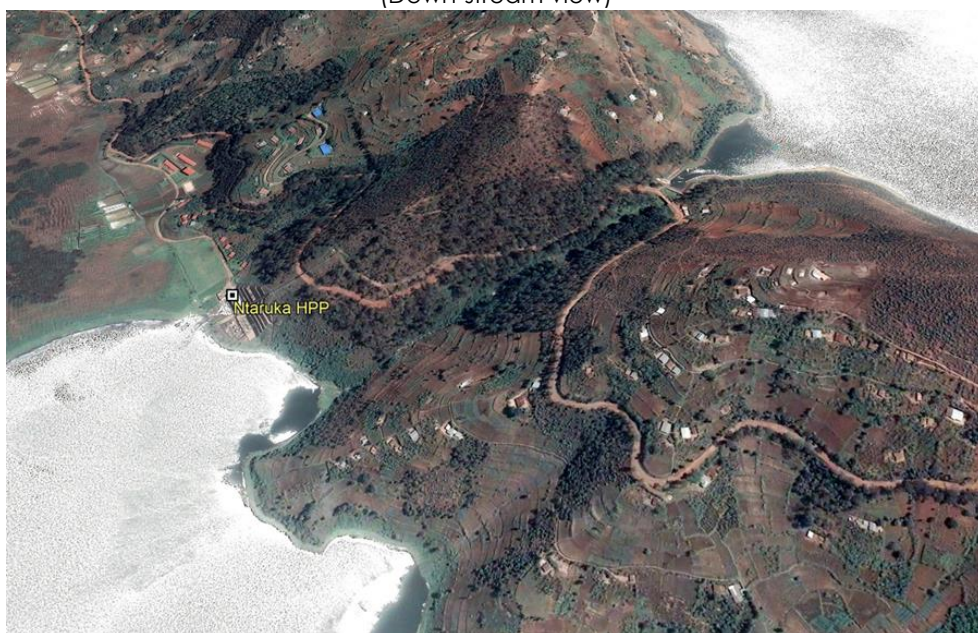
**Fig. 23: Potential inundation areas for The Ntaruka HPP**

Though Lakes Burera and Ruhondo are connected by the 600m long Ntaruka stream, the two lakes are separated by a dramatic drop in altitude of 100m (**Fig. 23**). The steep slopes mean that inundation would only occur in the area immediately adjacent to the Lake Ruhondo. Save for the Ntaruka HPP itself, the arear adjacent to the Lake is not inhabited.

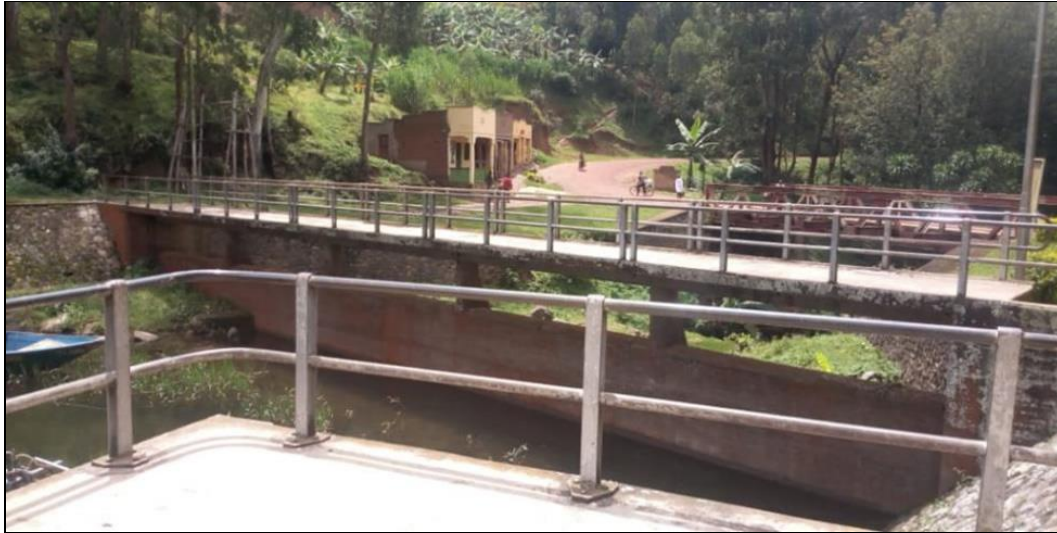
**Ntaruka dam**

The dam is a weir structure, made of concrete structure constructed across the original river bed. It has a height of 2.3m meters above the foundation grade and has a crest length of 25.7 meters. The gates are installed at 2m below the original river outlet bed.

Ntaruka HPP was designed with a strong weir to withstand both pressure in the reservoir and spillway water to flow over it. Spillway crest level is located at the elevation of 1864m. The audit tests indicated that the dam is strong enough to withstand water weight and spill way water in case of overflow.

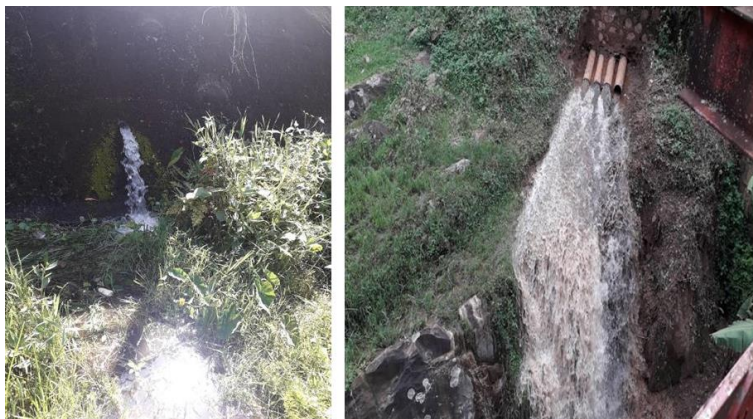
**Opening in the weir (left) and weir bypass facility (right)**

In 2016 following long shut down of the power plant due to damage caused during liberation war, the dam was equipped with facilities to allow for flow of water from the upper lake (Burera) to downstream lake (Ruhondo) through the original river bed. This would serve the same purpose in one of the following scenarios:

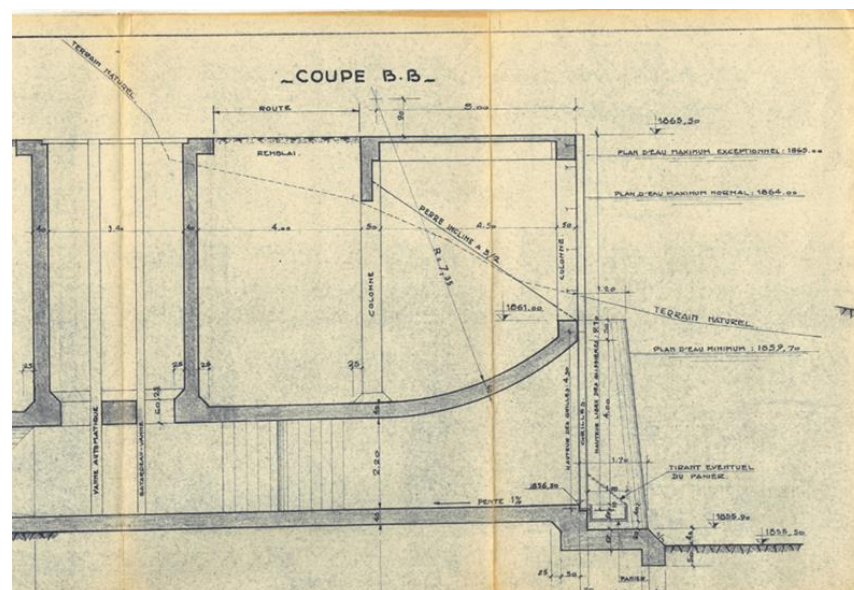
Trash rack and intake gates arrangement

The wing walls are made of gabions with cement joints. However, during the site visit it was observed that the wings of all the structure was partially washed-out on both side of the lake slope protection and showed vertical movement and cracks.

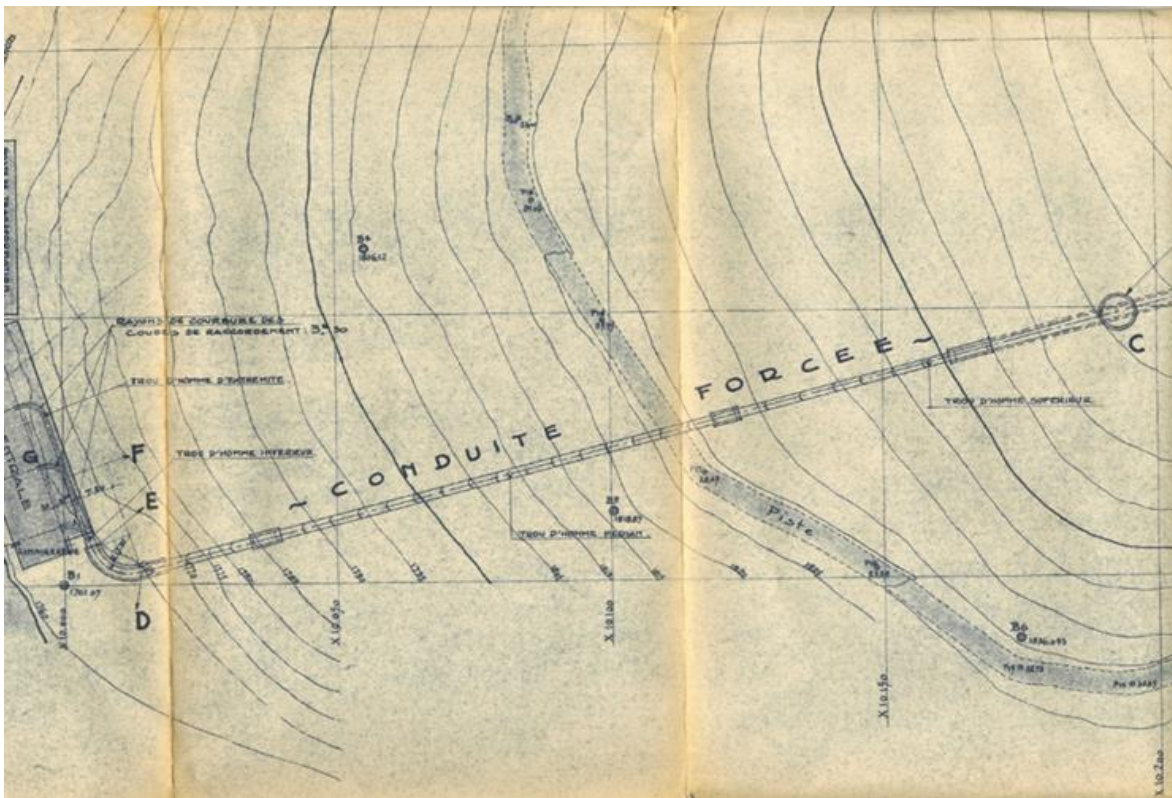
Penstock arrangement from construction design of 1957 (No updated map available at the plant)

The internal and external corrosion on the steel structure at all points tested is below 1mm, leaving an effective plate thickness of at least 14.42mm. Given that no more than 9.875% of the plate has been lost to corrosion over the last 60 years, the conclusion is that, the penstock is still in good condition and can serve for another 30 years.

All the penstock anchor blocks and supports for the foundations were found to be free from vertical and horizontal movement, except a minor horizontal movement on one support block foundation. Only a few of the anchor and support blocks were not clean, all anchor and support blocks were free of major surface discontinuities, and concrete damage and erosion, except for a minor crack on one support block.

Ntaruka hydropower plant has a 120m long steel penstock which, during the time of commissioning, had an internal diameter of 1800mm and a steel plate thickness of 16mm. It is supported by anchor blocks at different points (**Figure 5**).
